## CONVAIR ASTRONAUTICS

CORROSION AND LUBRICATION  
OF THE  
UMBILICAL PLUGGENERAL DYNAMICS  
ASTRONAUTICS

27 E 1061

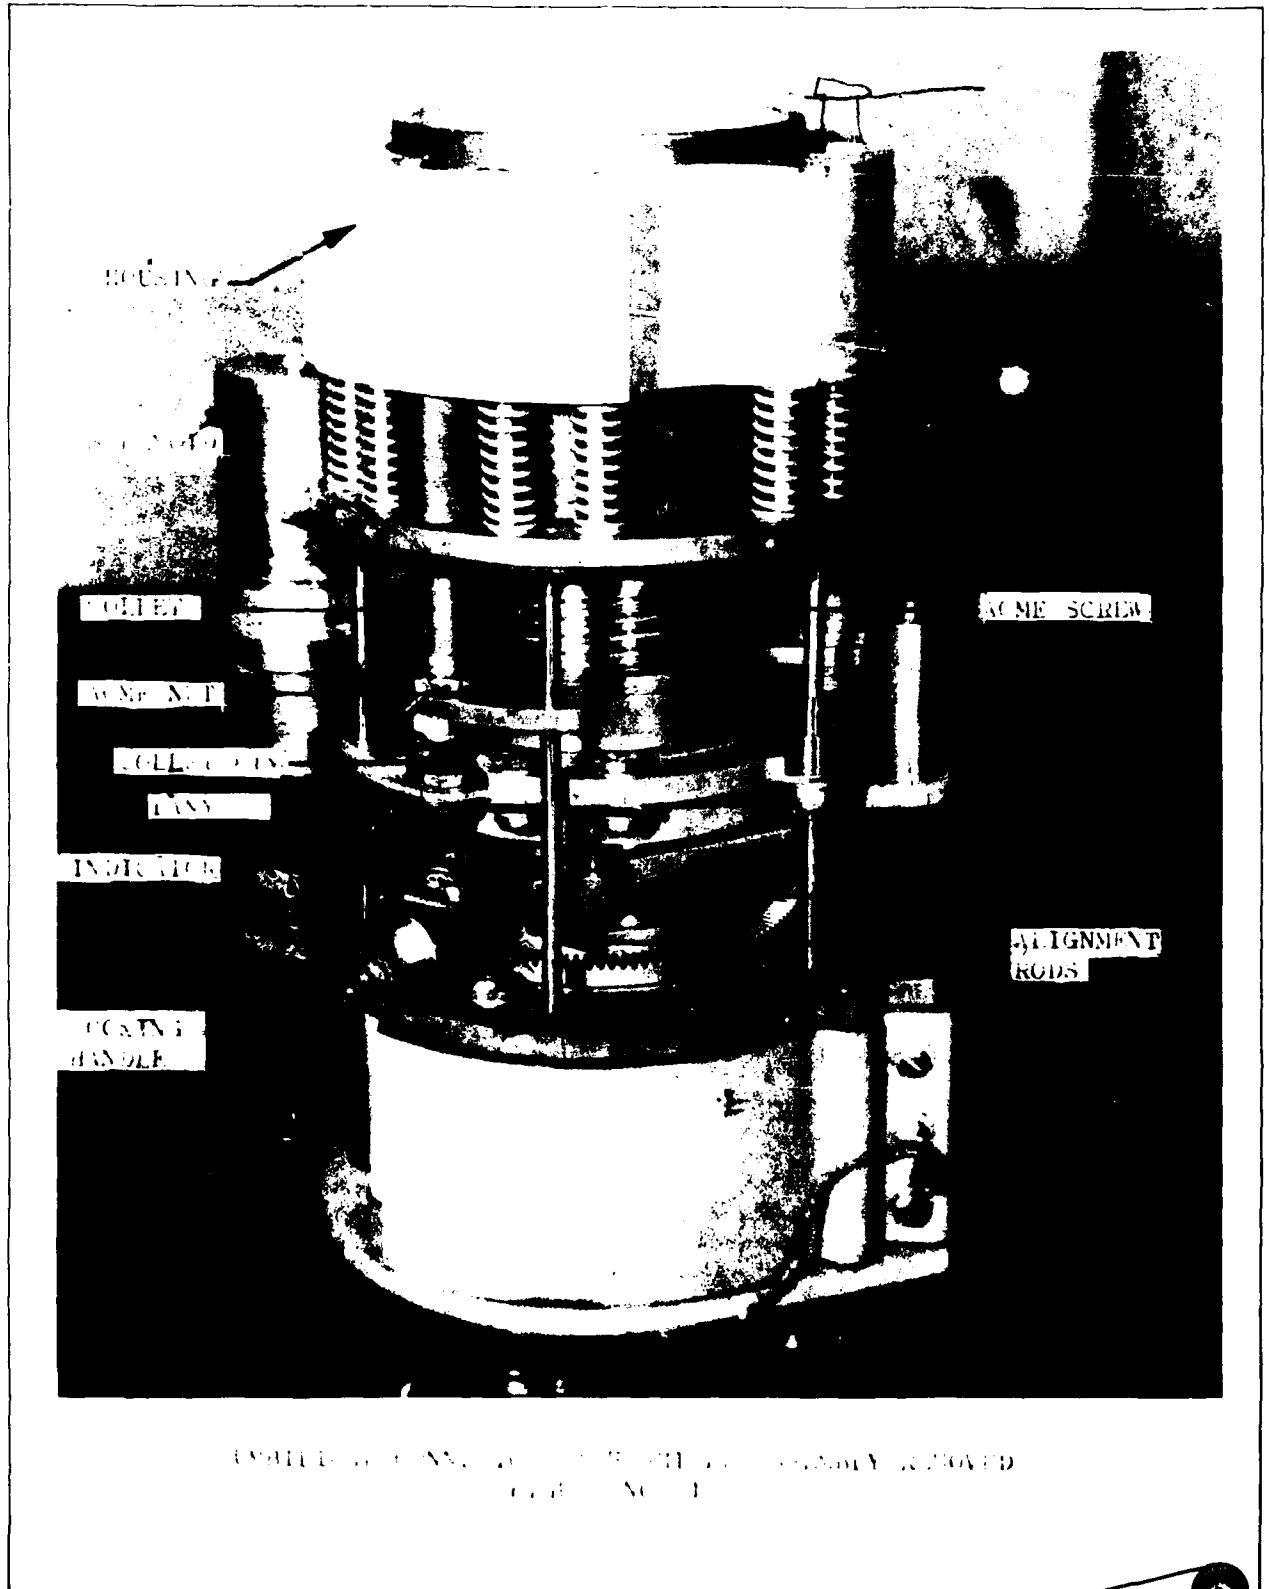
FIGURE 1  
UMBILICAL CONNECTOR WITH SHIELD ASSEMBLY REMOVED

- 3) Coaxial connections should be doubly checked to prevent poor electrical contacts.
- 4) Operators should rely on the indicator guide to determine when the plug is cocked. The indicator guide in Figure 1 shows the plug to be overcocked. When properly cocked the unpainted portion of the movable guide should be barely visible behind the stationary guide.

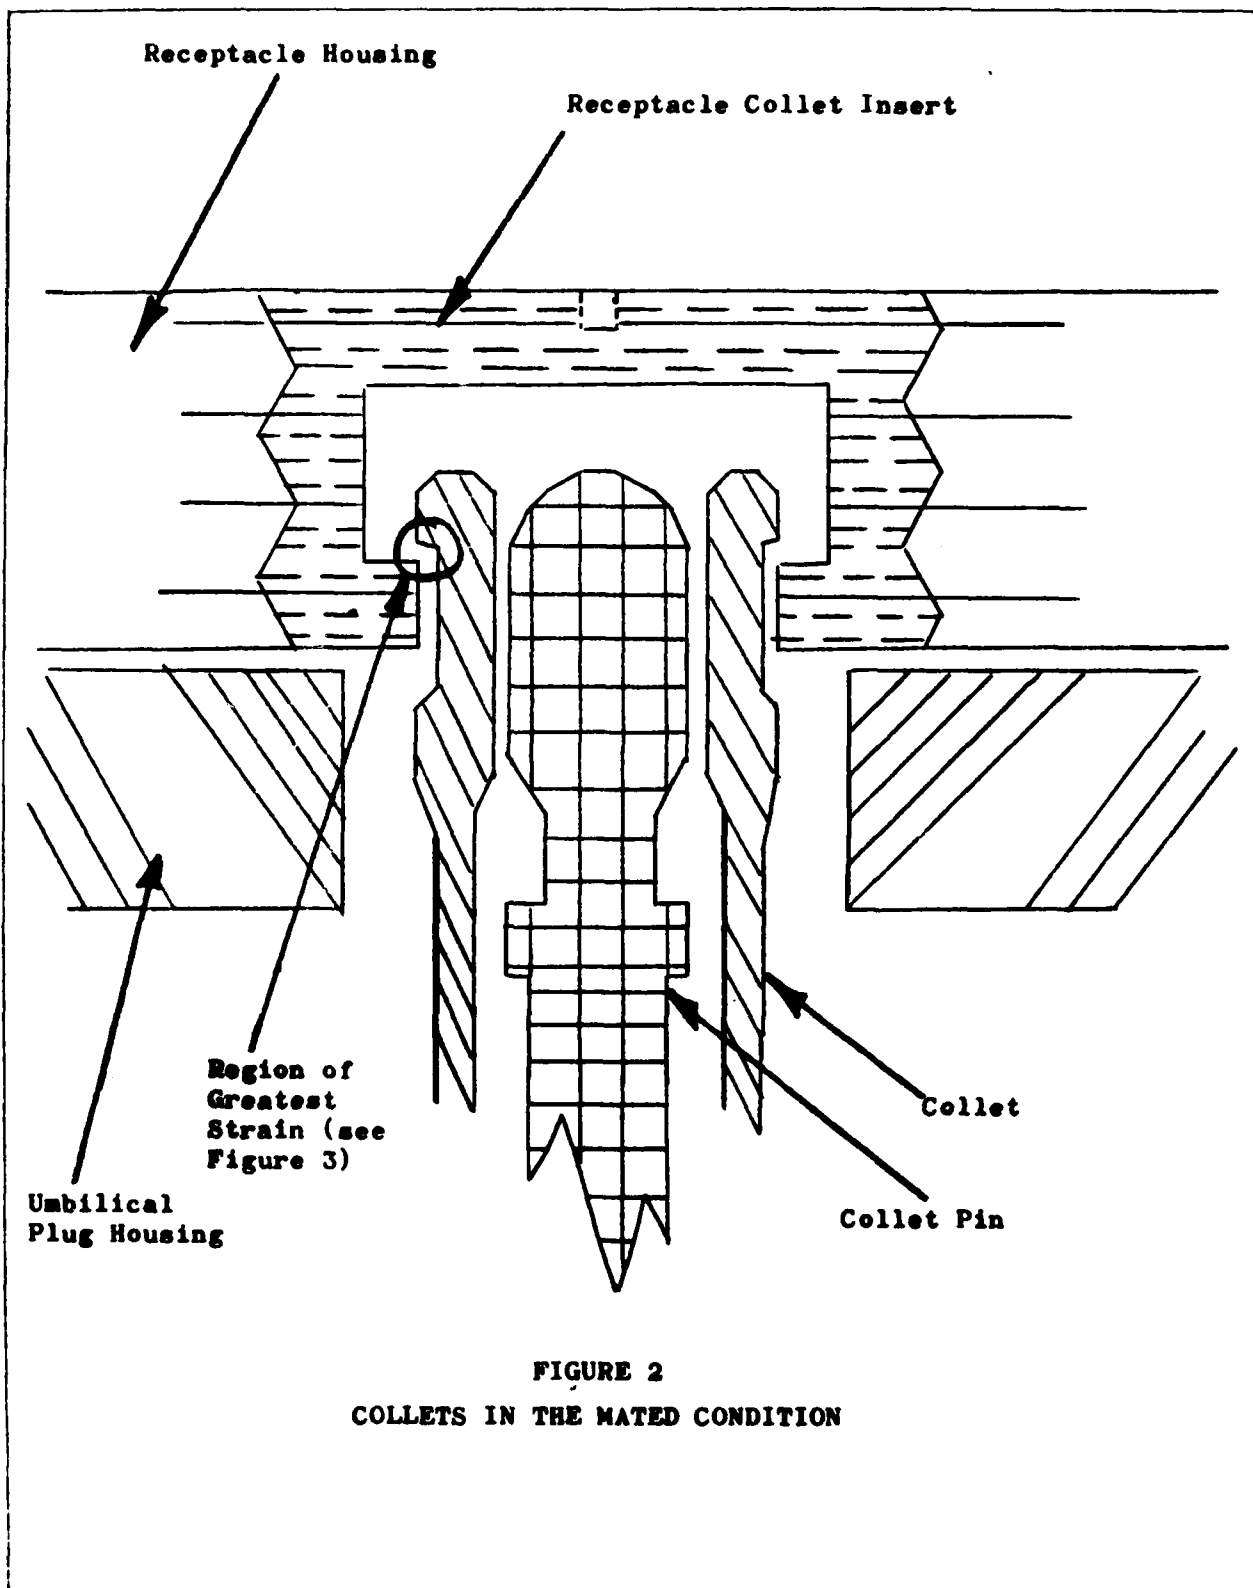
FIGURE 2  
COLLETS IN THE MATED CONDITION

- 5) The degree to which a mated plug is cocked affects the tension required for release. Cocking corresponds to pushing the cable upwards in Figure 2 while restraining the collets. The cable catch presses the collet into the collet pin and increases the friction surface. Movement at this friction surface becomes more difficult as the release springs are compressed and almost impossible if the plug is overcocked.

- 6) The encircled area on Figure 2 is subject to the greatest strain because the cable catch digs into the collet when the release springs are compressed. Figure 3 is a photomicrograph of this portion of the collet. It shows the damaged chrome finish and corroded base metal. Buffing this portion of the collet tip had no measurable effect on the tension requirements. Collet tips with a thicker chrome finish should better withstand the abrasive effects of repeated mating cycles. How well the thicker coating can withstand the excessive localized forces associated with overcocking is pure conjecture. The collet tip was the only area of corrosion, visible on the assembled plug, which might possibly interfere with a successful disconnect.

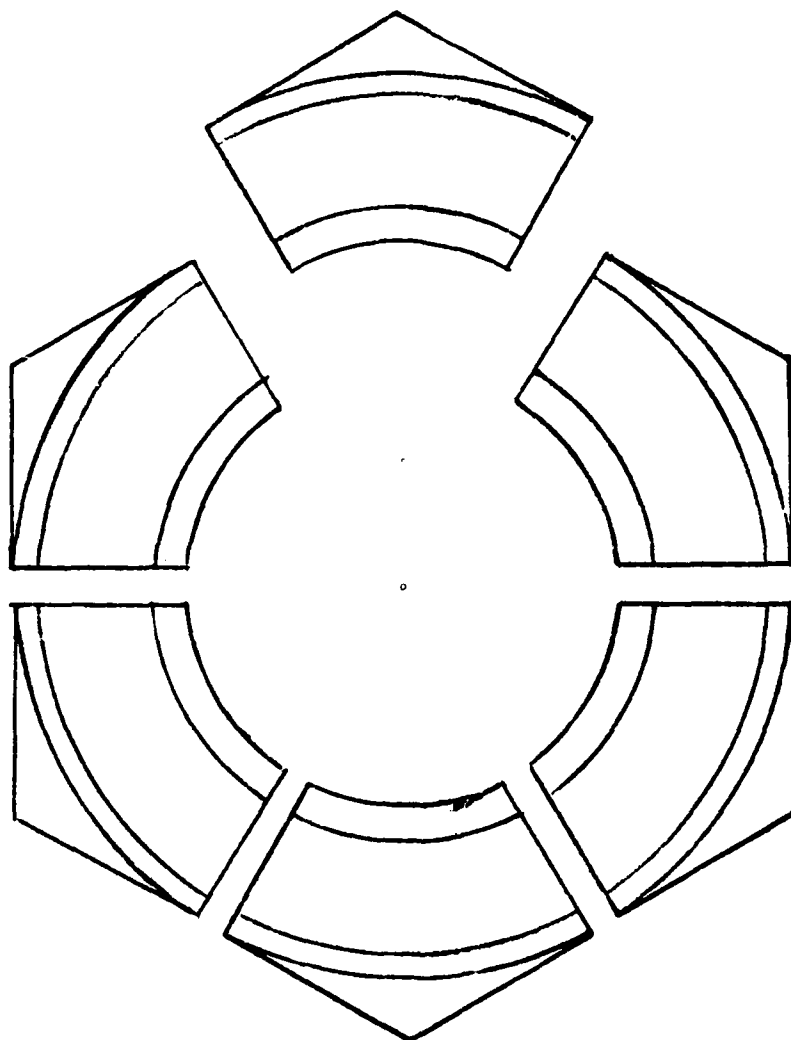
**FIGURE 4**  
**BENT COLLET LEAF (TOP VIEW)**

- 8) A coaxial connection to a "canon" plug was not secured. Although the shielding was exposed, the fitting which assures positive electrical contact was not tightened. This type of electronic wiring defect can seriously affect the reliability of an important monitoring circuit. Some collet leaves are bent. Figure 4 shows how a bent collet leaf appears when viewed head on. Collets which have bent leaves no longer satisfy the Grey and Huleguard Engineering Drawing P/N 562-340. Collet tips which fail to contract when the collet pin is retracted can interfere with a successful disconnect. A collet cannot rapidly extricate itself from the cable if one of its leaves hang up.

- 5) Plugs with bent collet leaves should be removed from service as they no longer satisfy the Engineering Drawing (Gray and Huleguard 562-340). They can be detected by retracting the collet pins while observing the extended collets. Figure 4 shows a bent collet leaf which did not contract.
